RADCO TEST REPORT
Test Report No. RAD-4093
Project No. C488A

**Racking Shear Tests on Wallpanel Anchored Assembly
per ASTM E72**

Wallpanel Inc.
P.O. Box 13023
Prescott, AZ 86304

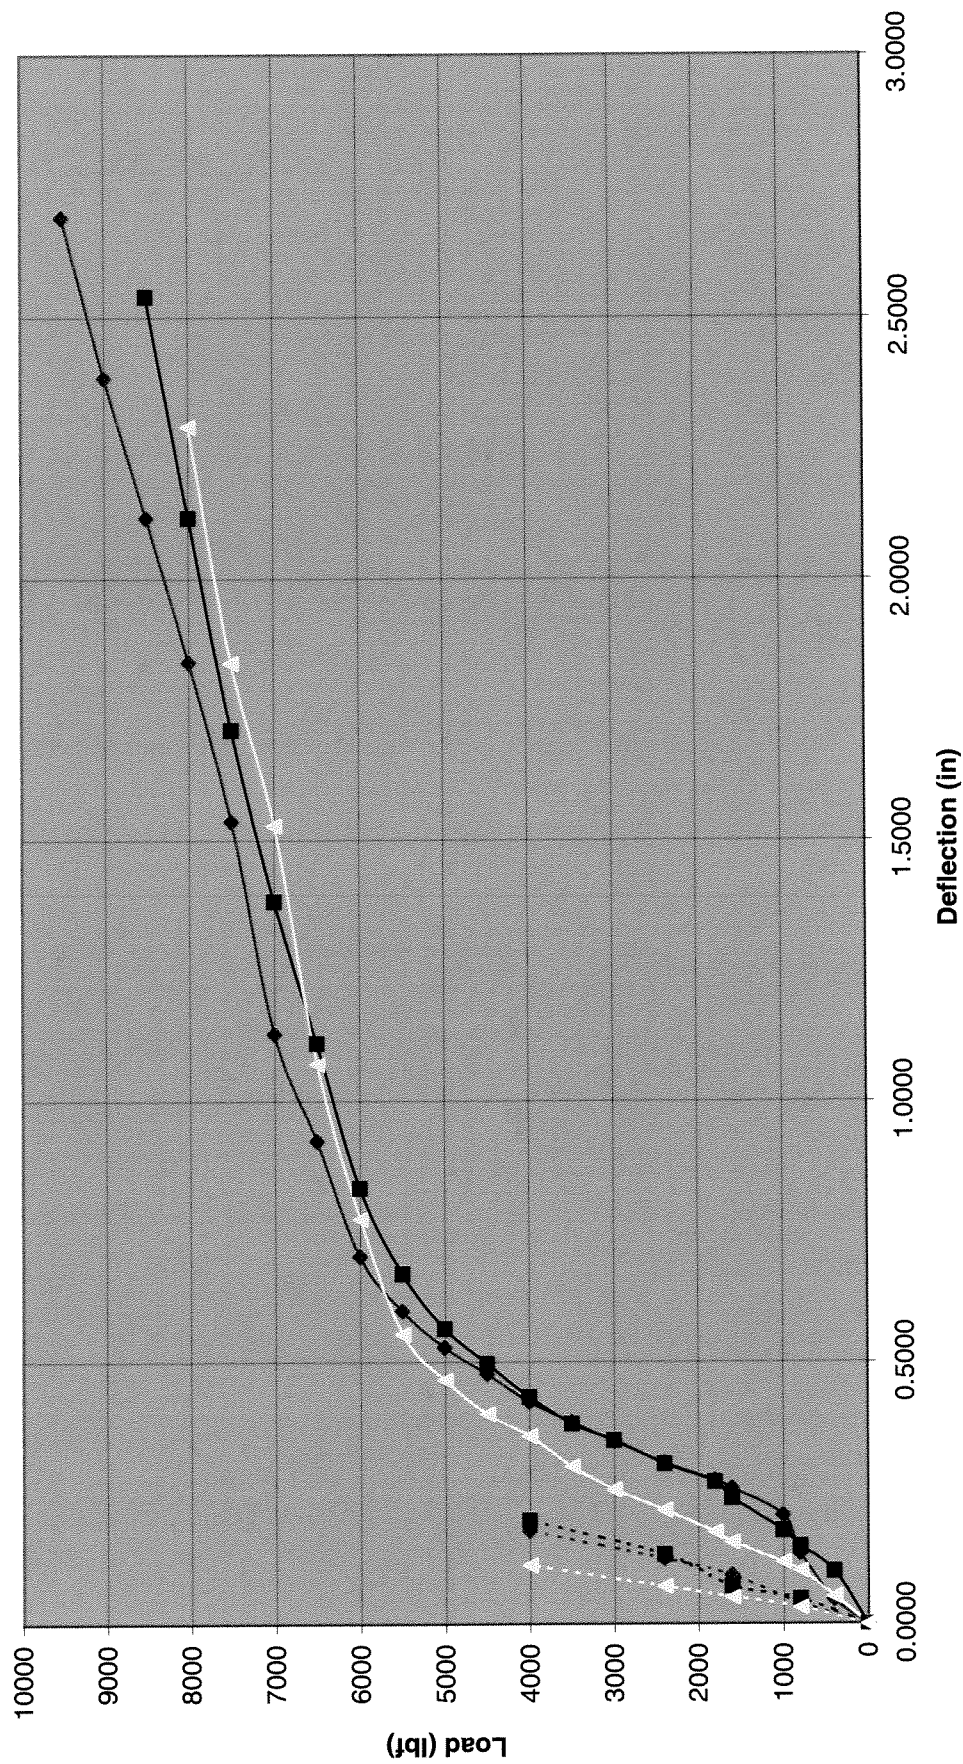
APPENDIX B
LOAD VS. DEFLECTION CHART

Racking Shear Load vs. Deflection

Test Number	Ultimate Load (lbf)	lbf/lineal ft.	Load @ 1/8" Deflection (lbs.)	lbf/lineal ft.
1	12000	1500	752	94
2	13100	1638	592	74
3	14300	1788	1120	140
Average	13133	1642	821	103
Std. Dev.	1150	144	271	34
