**TimesOne™**  
The Energy Efficiency Company

**Power Correction Systems, Inc.**

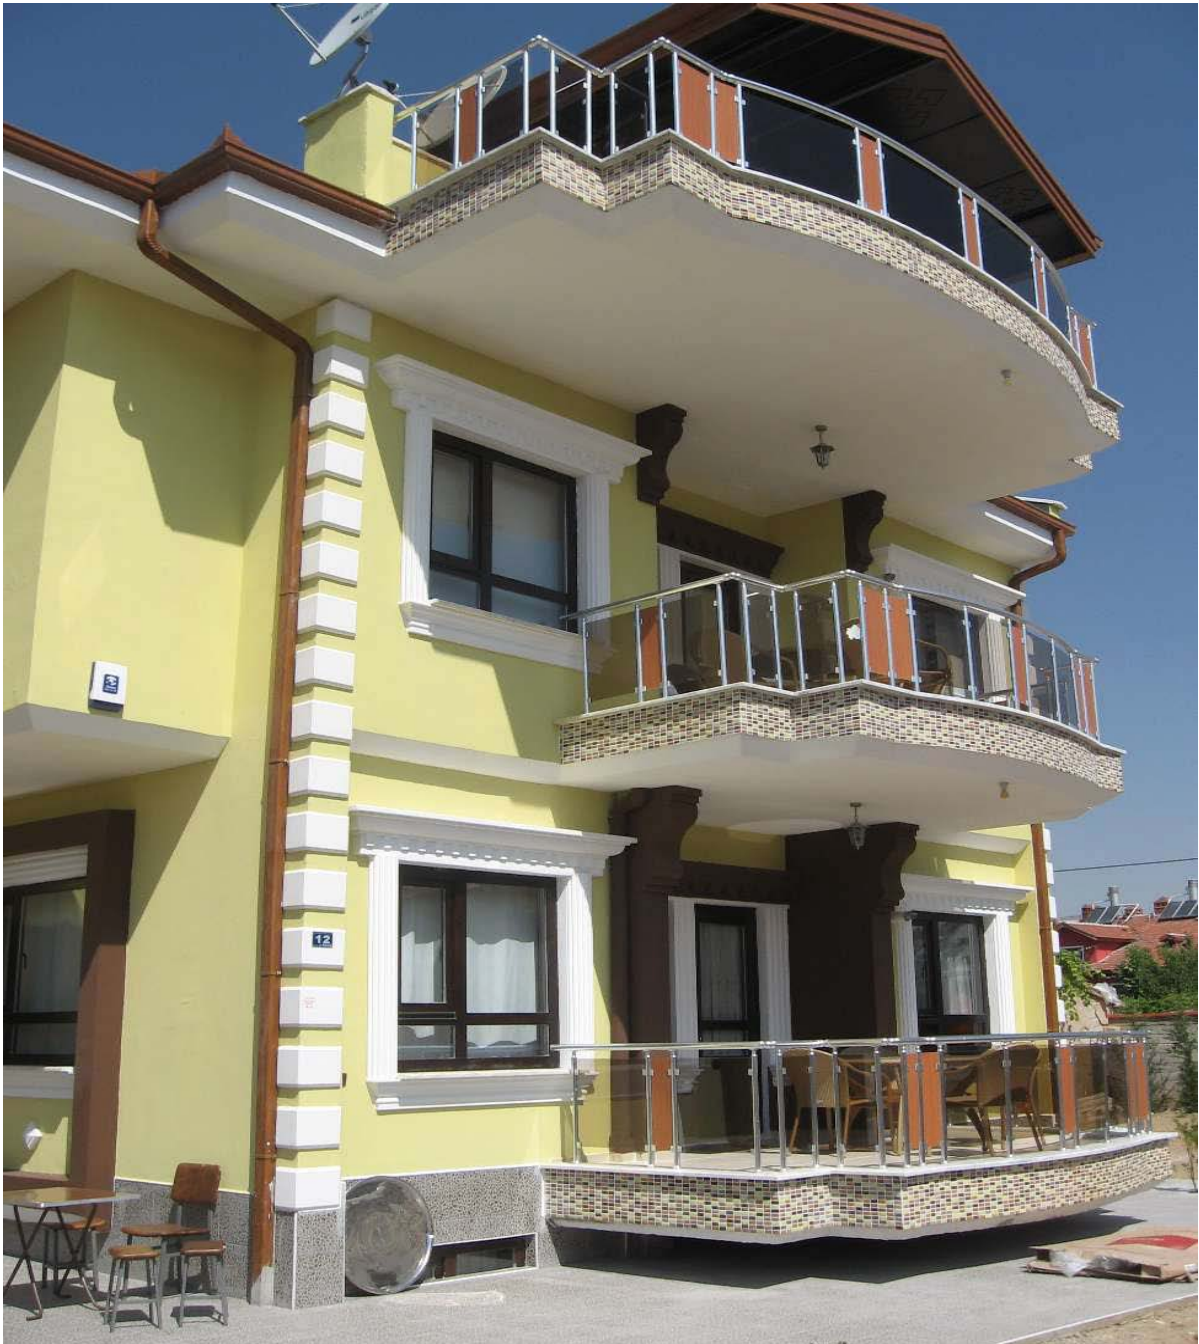
**EXTERIOR OF THIS MINISTRY HOUSE WAS PAINTED WITH MULTICERAMICS  
TINTED WITH CERAMICS**

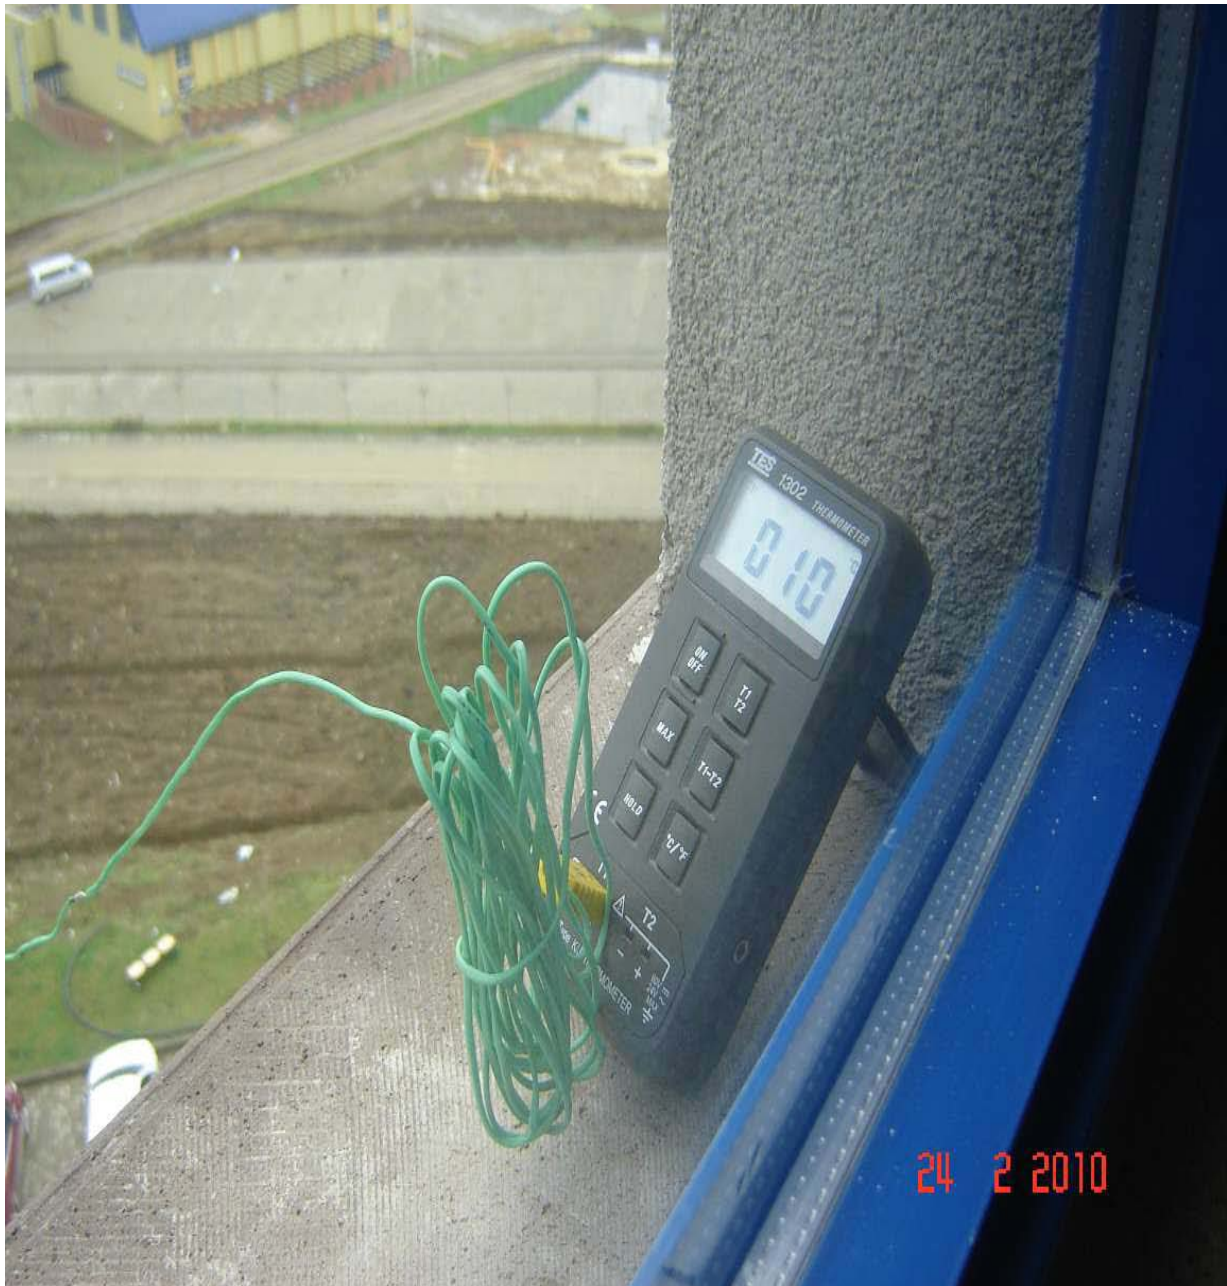
**EXTERIOR TEMPERATURE WAS CONTINUOUSLY TRACKED AND THE DIFFERENTIAL TEMPERATURE AFTER THE ONE DAY CURING TIME WAS 11C**
